Manhole Inspection Summary

Manhole # S31GG1027MH

Insp Date: **12/8/06 10:35 AM**

Location Address: **225 LINKWOOD RD**

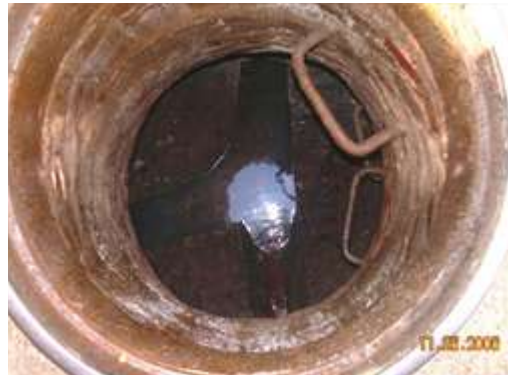
Top View

Frame leaks. Corroded steps. Evidence of surcharge - Bench debris. Channel debris.

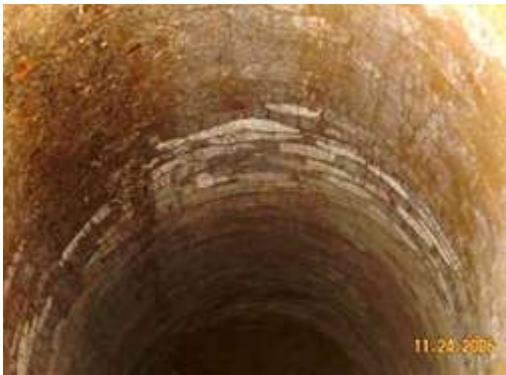
Defect

Adjustment infiltration.

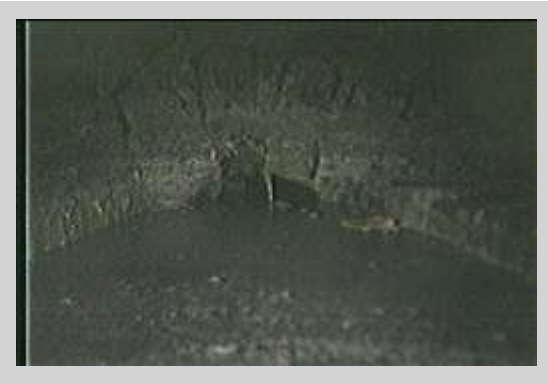
8 in. Circular Gravity Sewer Pipe Out @ 12 O'Clock

Deposits: ☐ None ☒ **Mud** ☐ Sludge ☒ **Debris** ☐ Grease

Silt Depth: **1.5** (in.) Deposits Extent: **Light**

Infiltration: **None** Pipe Seal Cond: **Cracked**

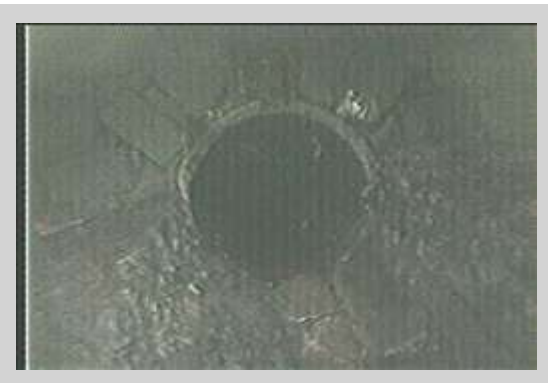
8 in. Circular Gravity Sewer Pipe In @ 6 O'Clock

Barrel deterioration and infiltration. Channel deterioration.

Deposits: ☐ None ☒ **Mud** ☐ Sludge ☒ **Debris** ☐ Grease

Infiltration: **Evidence** Pipe Seal Cond: **Cracked**

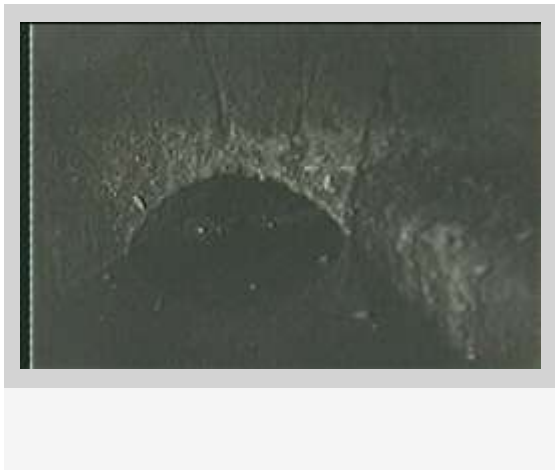
8 in. Circular Gravity Sewer
Pipe In @ 9 O'Clock

Deposits: ☐ None ☒ **Mud** ☐ Sludge ☒ **Debris** ☒ **Grease**

Silt Depth: **1.5** (in.) Deposits Extent: **Light**
